Descriptions of the Animas River-Cement Creek Confluence and Mixing Zone near Silverton, Colorado, during the Late Summers of 1996 and 1997

U.S. Geological Survey Open File Report 2005-1064

by Laurence E. Schemel and Marisa H. Cox

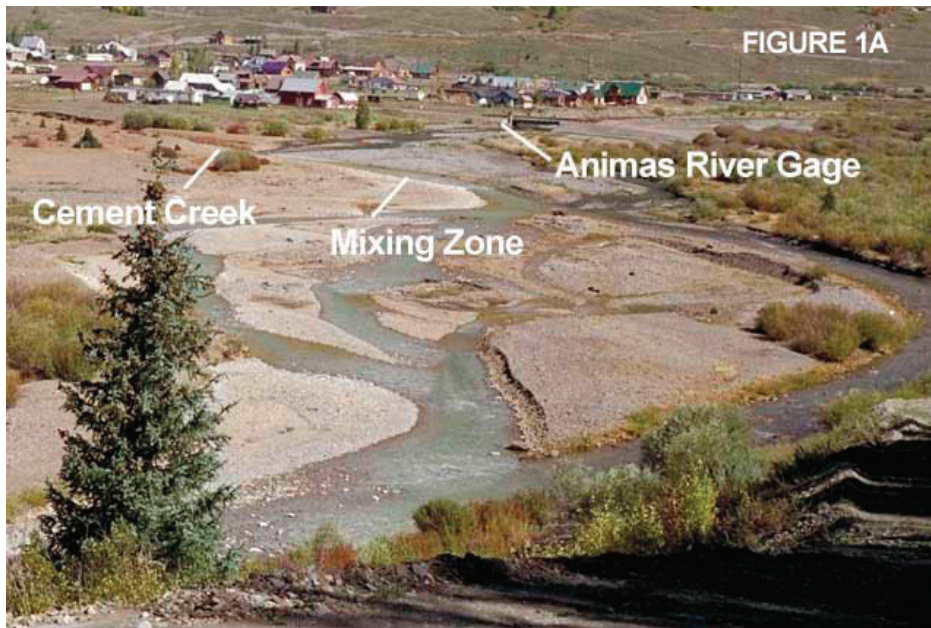
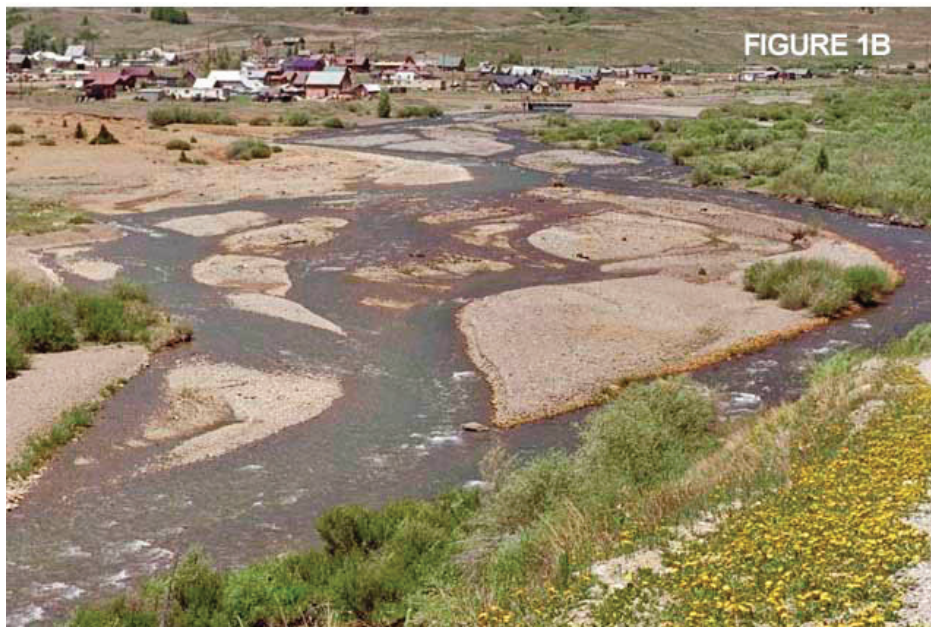
Figure 1 shows photographs of the Cement Creek-Animas River confluence and the network of channels downstream during late summer 1996 (A) and 1997 (B). Discharge from the upper Animas River flowed under the bridge at the location of the Animas River gage (shown in A). In both years, the river formed two main tributaries below the gage. The left-side (of the photograph) tributary discharged directly to the (primary) confluence with Cement Creek, and the right-side tributary flowed to locations downstream from the primary confluence. Most of the flow from the right-side tributary was carried by a channel (far right) around the area labeled “Mixing Zone” (Figure 1A) and the network of channels immediately downstream. Therefore, a secondary confluence of Animas River inflow with partially mixed waters from the Mixing Zone was located at bottom of the photographs shown in Figure 1. Consequently, complete mixing of Cement Creek with the Animas River occurred over several hundred meters in both years. In 1997, however, additional braiding of discharge from the Animas River was evident between the two main tributaries identified above. In addition to the left tributary, one braid discharged near the primary confluence with Cement Creek, and two additional braids discharged to the Mixing Zone downstream (Figure 1B). The distribution of inflow from the Animas River in 1997 neutralized inflow from Cement Creek in a more gradual fashion than had been the case in 1996, which preserved and intensified the across-channel gradients in the Mixing Zone that are described below.

The photographs presented in this report provide visible evidence of chemical gradients across the channel in the Mixing Zone and pH-dependent chemical reactions involving metals that were supplied to the confluence primarily by Cement Creek. In addition, they illustrate significant year-to-year differences in the ways these two streams mixed due to changes in the streambed and channel braiding.

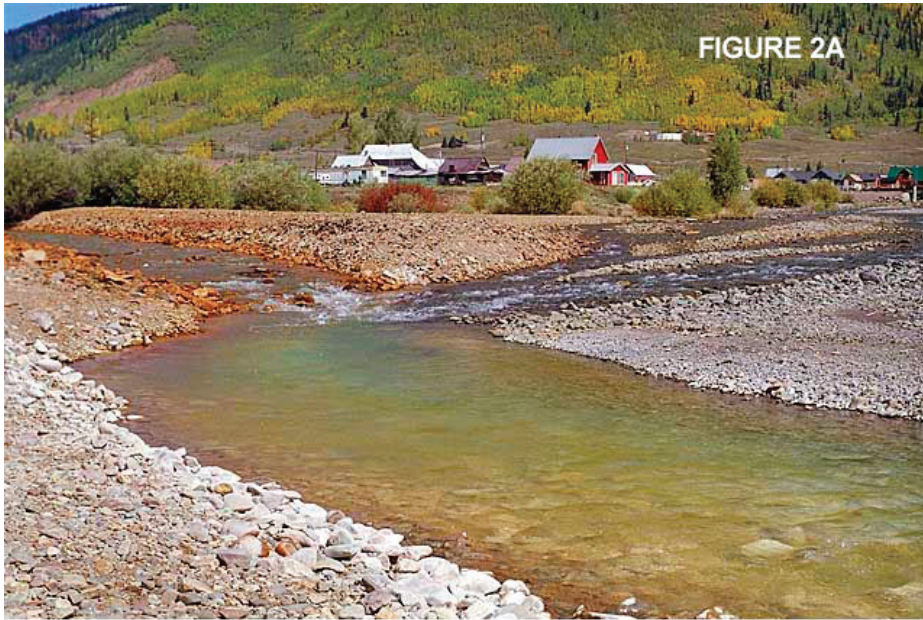
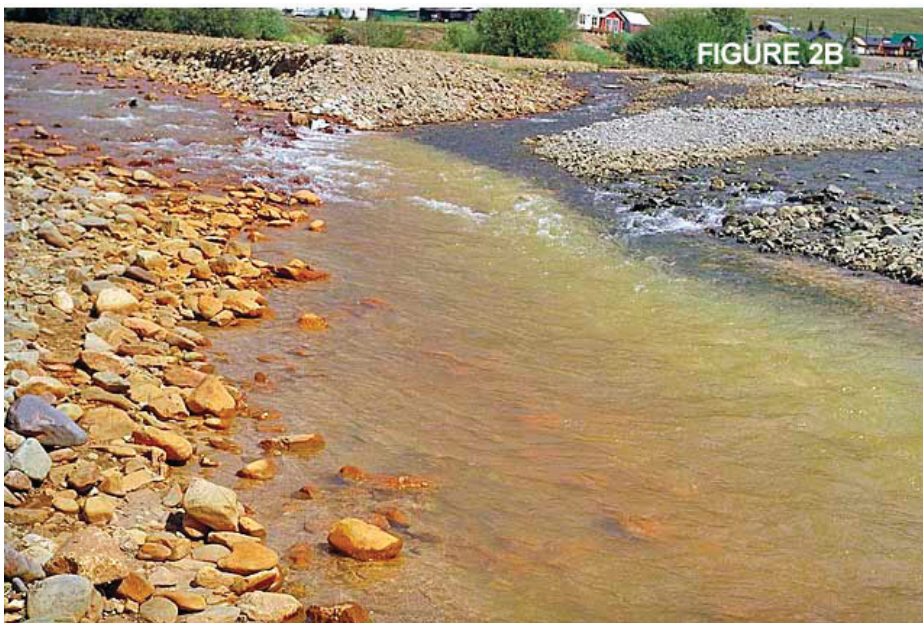
Figure 2 shows details of the confluence of Cement Creek (left inflow) and the Animas River (right inflow) in 1996 (A) and 1997 (B). Rocks that line the bank of Cement Creek were red because some (ferric) iron precipitated even at the low pH. The Animas River inflow was clear and the bank was not coated because concentrations of metals that would precipitate at its circum-neutral pH were relatively dilute. Mixing of the two streams resulted in the formation of colloidal particles of both iron and aluminum (oxy)hydroxides. The “opalescence” in the water column of the Mixing Zone was due to light refraction by the colloids. Precipitates coating the left-side bank of the Mixing Zone were iron- (red) and aluminum- (white) rich mixtures. In the Mixing Zone, red precipitates were found nearest the confluence (Figure 2B), but white precipitates generally dominated farther downstream (Figure 2A). As shown in both photographs, the water column was clear near the right-side bank and the rocks were not coated because the two source waters were not well mixed across the channel.

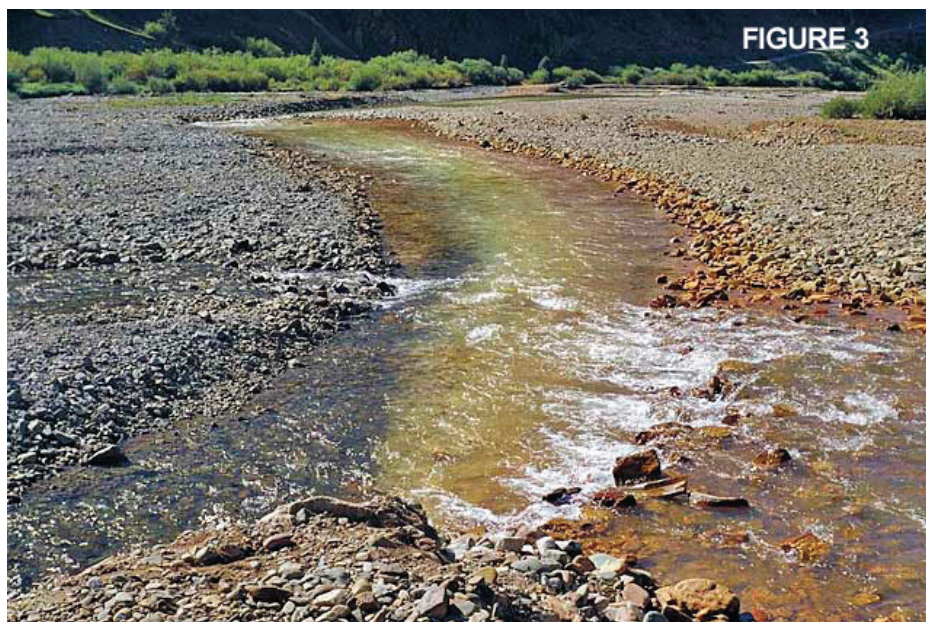
Figure 3 is a view of the Mixing Zone looking downstream from the confluence of Cement Creek with the first two inflows from the Animas River in 1997. It clearly shows the lack of coatings on bank rocks nearest the Animas River inflows and red coatings on the right-side bank, nearest inflow from Cement Creek. Although distinct banding was apparent in the Mixing Zone waters, this effect was primarily the result of coatings on the substrate. Red coatings near the right side indicated iron-rich precipitates, which can form at a pH lower than the pH range where aluminum precipitates. In mid-channel, white coatings indicated aluminum-rich precipitates formed as the pH was raised by mixing with the Animas River. The presence of additional inflows (braids) from the Animas River in 1997 preserved the banding pattern much farther downstream than was the case in 1996.
